Copper Loss from a Coppercoat Antifouling System over Time

Report V7

Reference:	PMA 257
Client:	Coppercoat
Date:	June 2019
Prepared by:	PML Applications Ltd

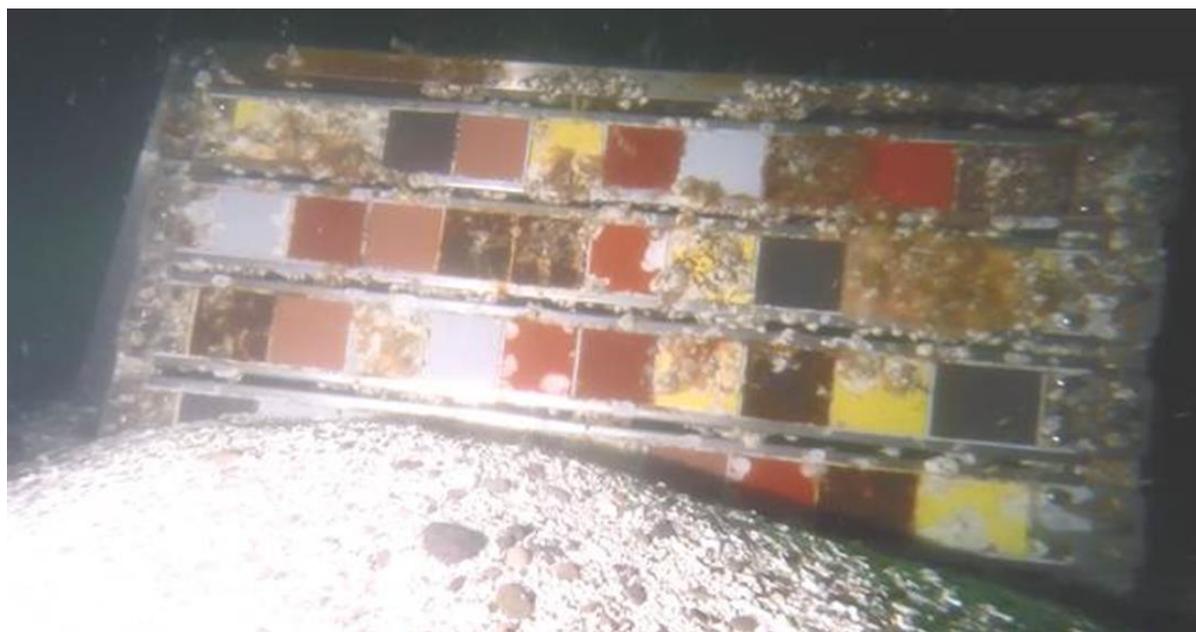
Figure 2: Still from ROV footage showing accumulation of debris against the bottom 2 rows of panels.

- On the east facing side the debris has built up to the extent that the concrete base and most of the bottom 2 rows of panels were obscured. Stones were also seen wedged between the rows of panels, suggesting that previously currents have been strong enough to lift and carry large debris which would have made contact with the panels even on the top row

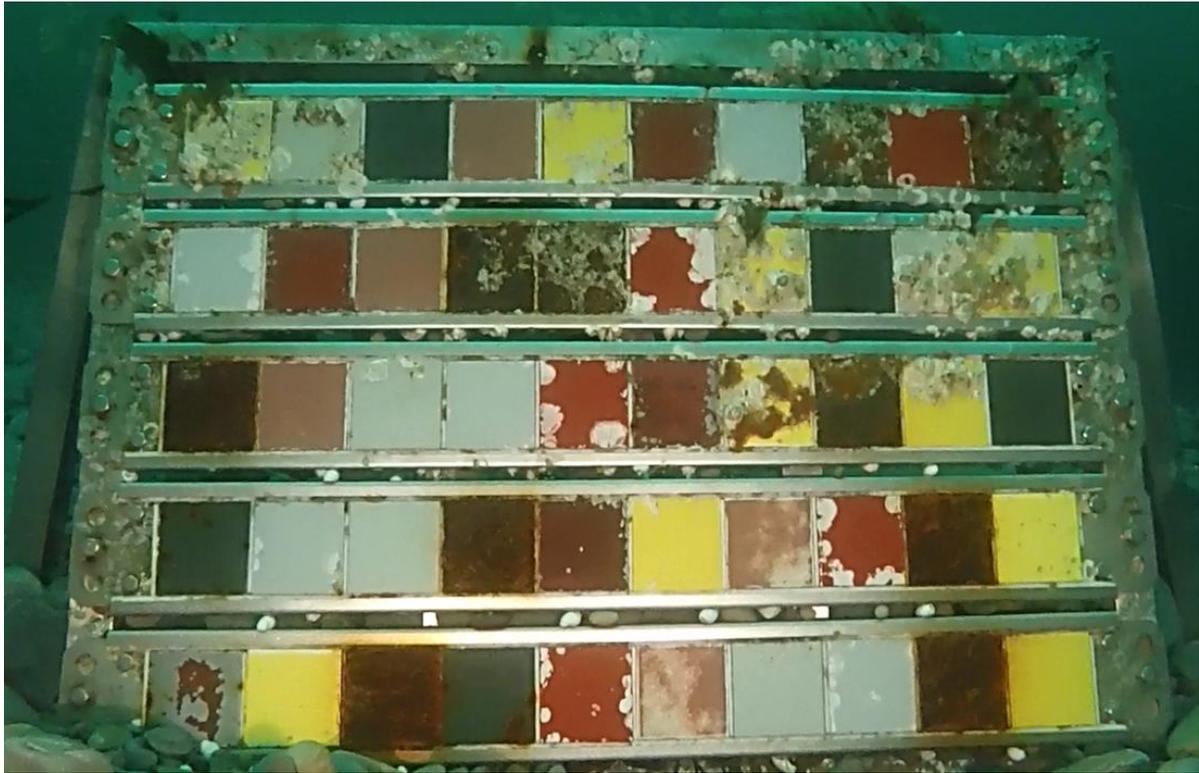
- Debris was clearly building up around the lander on the 2015 survey, but was much less evident on the 2016 visit. The lander did not appear to be in a depression, and no banking of debris was seen against the sides therefore it was decided that the lander should remain in that current position and not be lifted and moved.
- Five rows of panels were visible on the east side, as opposed to three the previous year. However the bottom row on the west side was then mostly obscured by debris.
- It seems likely that debris possibly increases and decreases periodically around the lander. The panels were clearly still being subjected to scouring by debris picked up and carried in strong currents, and to a larger extent than seen in 2015. While fouling levels in 2016 were generally at lower levels than seen in 2015, possibly due to scouring, damage to panels was still of great interest.

Figure 3: Still of deployed pod from ROV footage in 2016.

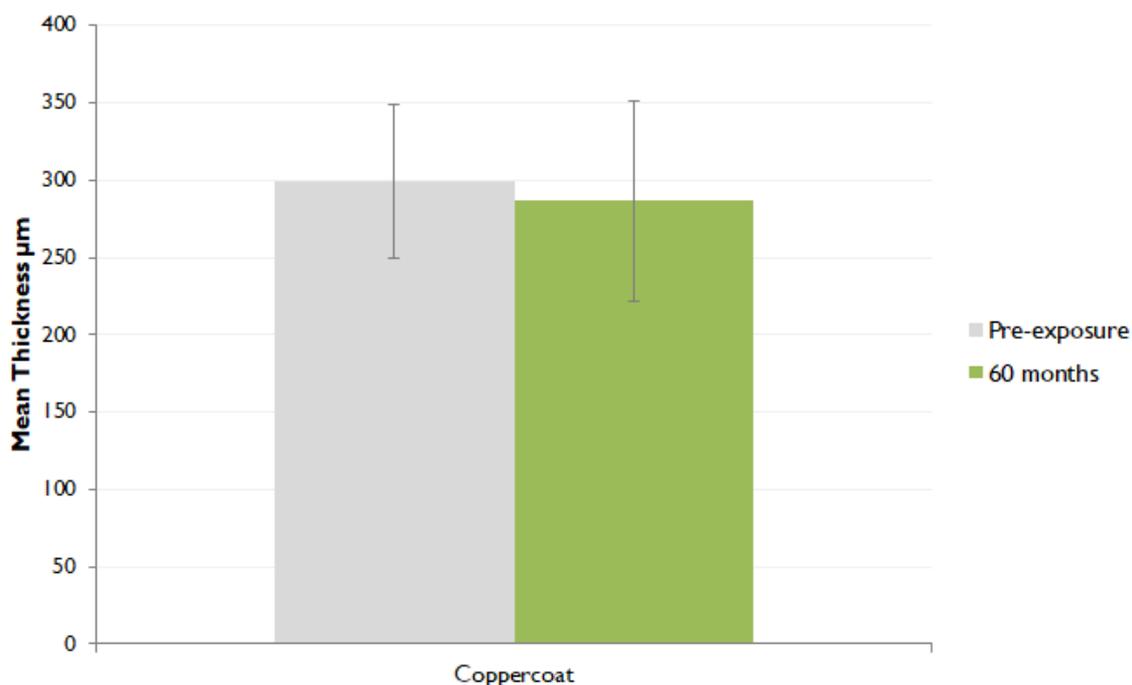
Coppercoat showed little significant change in thickness over time, excluding inter-panel variability.

Figure 6: Mean coating thickness pre-exposure and at 60 months. Error bars show standard deviation, and n=144 & 70 respectively.

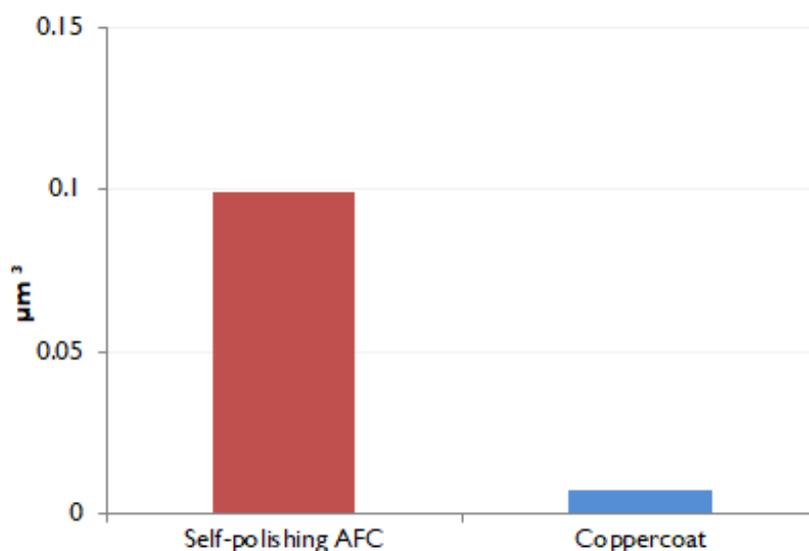
From 2012 till 2017 we have measured a mean reduction of coating thickness of 12.894 μm , this translates to a rate of 0.0071 μm per day (12.894/1825=0.0071). This result is compared to a different self polishing coating system also tested during the trials which showed a mean reduction of coating thickness of 0.0992 $\mu\text{m}/\text{day}$ or 181.04 μm in total.

In other words, the thickness reduction of Coppercoat represented circa **4.3%** (End thickness \cdot 100/ Start thickness = 95.69 this is % of remaining thickness. Then 100 – 95.69= 4.3 thickness loss) of the original DFT of the whole scheme. The competitor brand showed a reduction of ~29.35% of the DFT of the whole scheme.

Figure 7: Loss of volume per day.

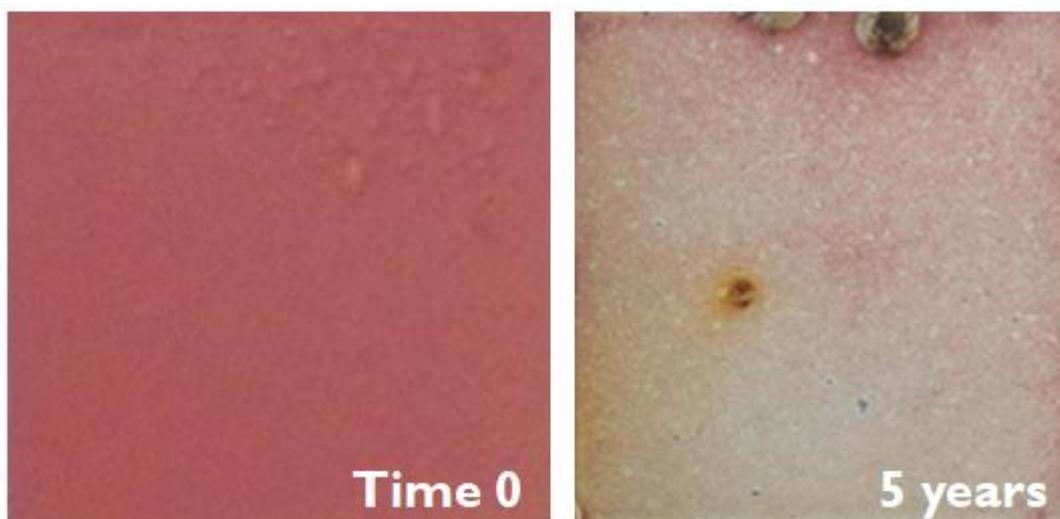
As stated by the manufacture, the top coat of the competitor brand was assumed to have an average thickness of 125 μm . From our results, therefore, we can assume that by the end of the testing period of 5 years between 90 and 100% of the top coat, and up to 106 μm (17% - tie coat loss \cdot 100 / start thickness) of tie coat had been lost from this self-polishing system.

Figure 8: Top coat loss over 5 years – Self polishing anonymous coating system.
